SUMMARY CONDITION REPORT

**Former Aberdeenshire
Council Premises,
Nethermuir Road,
MAUD
AB42 4ND**

Bairnecessities Baby Bank

Date: July 2023

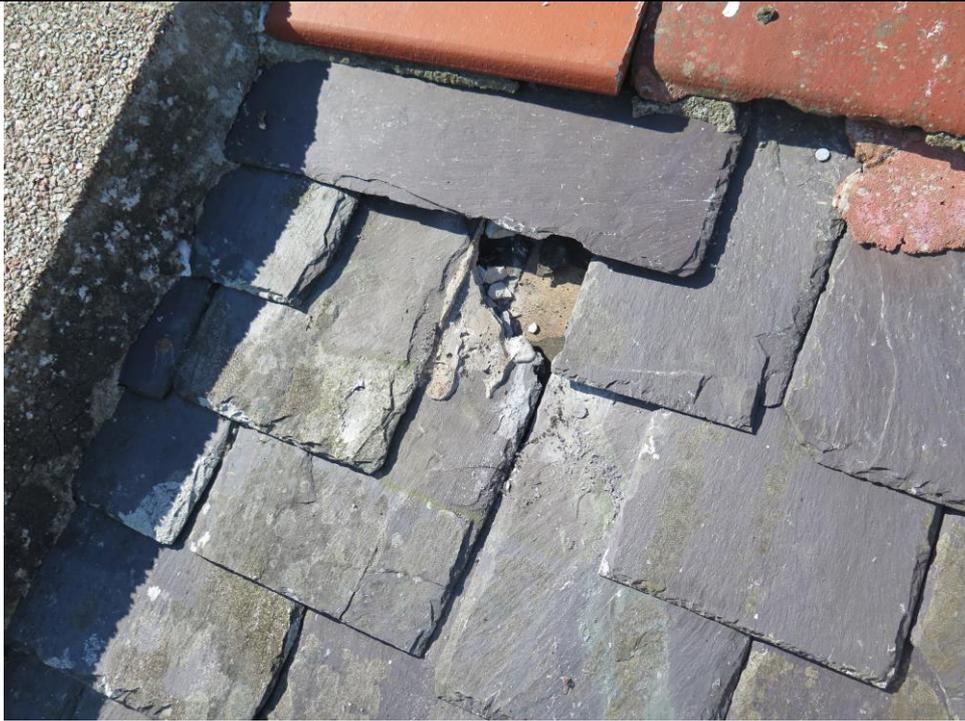
7

- 2.01 The roof is a pitched and slated construction with regularly sized 'welsh' natural slates, which are provided with galvanised steel clout headed nails or fixings and a unreinforced bituminous felt underlay. There are a very small number of damaged, cracked or missing slates, and the fixings show very little evidence of corrosion and therefore largely free of any significant nail sickness. We would estimate, given the construction, that the roof was likely to have been re-slated circa 1970's to early 1980's.

Area of opened up slating to expose condition of fixings / underslating felt.

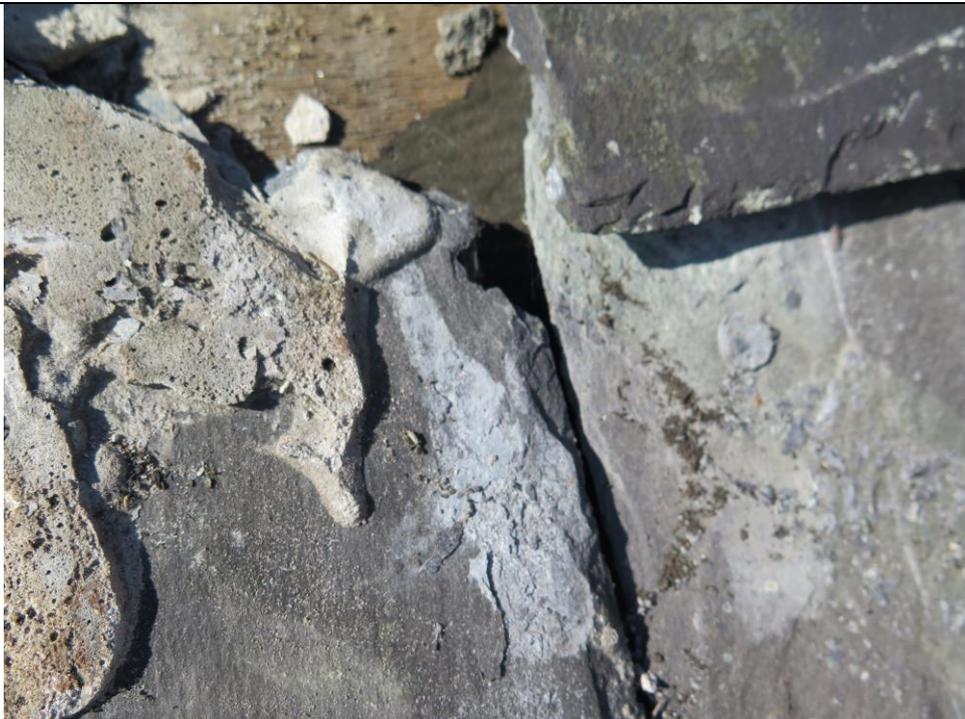
8

Area of opened up slating to expose condition of fixings / underslating felt.

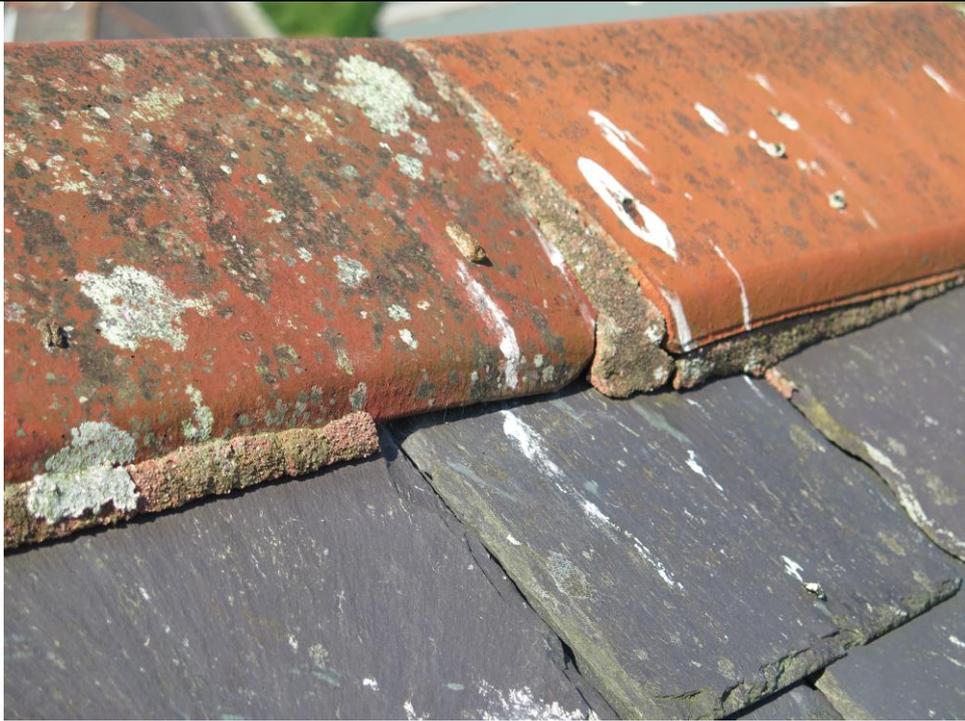
9

- 2.02 The ridge is finished with traditional angular fireclay ridge tiles bedded on a cement mortar bed and provided with matching cement mortar pointed joints. There were minor areas of cement mortar pointing missing between ridge tiles and ridge tiles and slates. Minor pointing repairs may be required.

Open mortar pointing below / between fireclay ridge tiles.

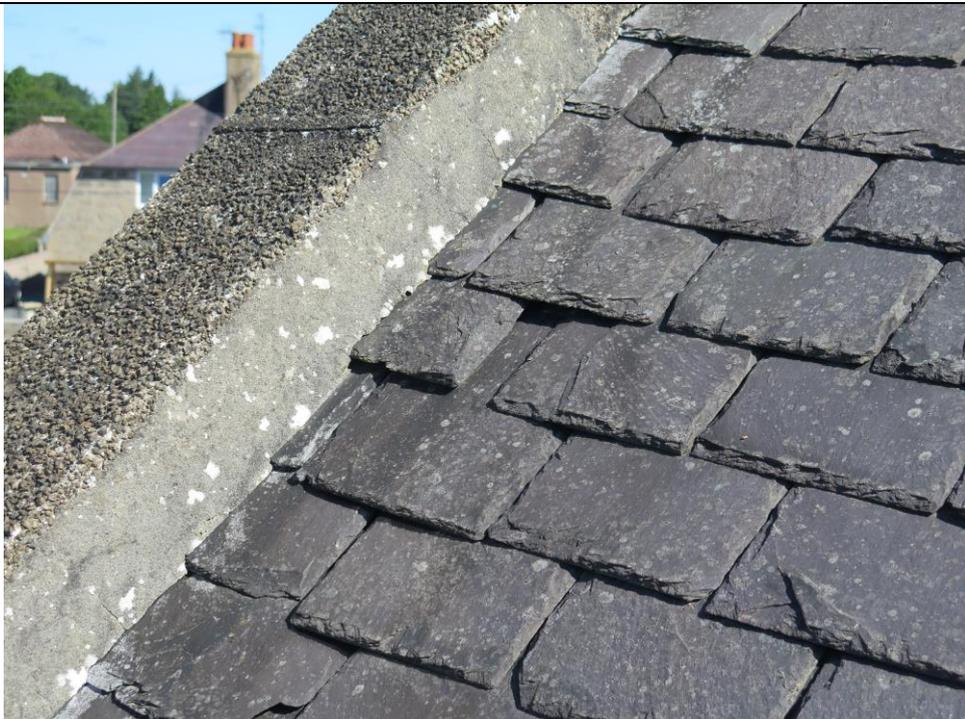
10

- 2.03 The junction between the slated roof and gable wallheads are formed in a traditional skew detail, with a modern brushed exposed aggregate pre-cast tabling or coping and a cement mortar pointed skew junction between the tabling and slating. There are areas of cracking or holing of the skew pointing, and evidence of previous patch repairs to cracked skews at the north west and south west corners. It would be prudent to consider hacking out and repointing skew junctions and skew tabling.

Typical cement mortar pointed skew details.

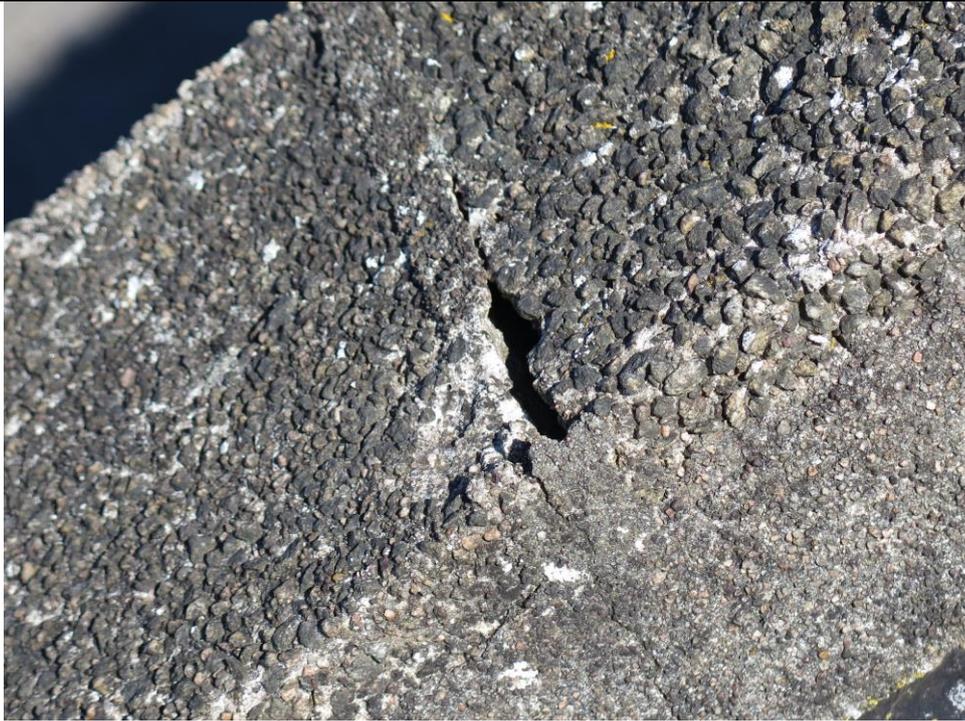
11

Open pointing in joints in brushed exposed aggregate tabling / coping.

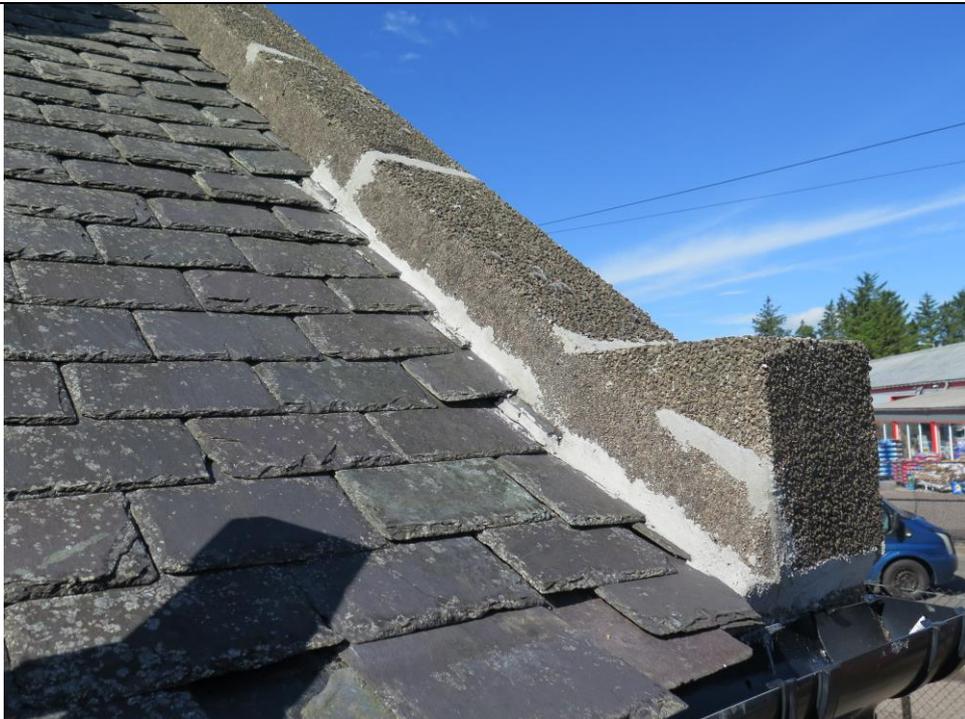
12

Previous pointing patch repairs to brushed exposed aggregate tabling / coping.

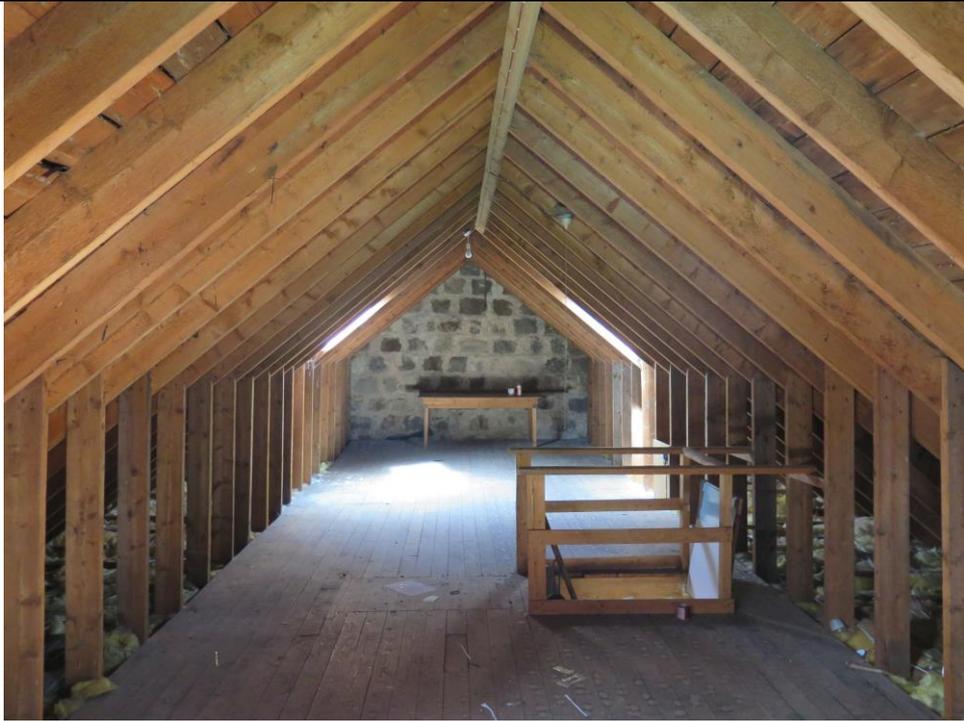
13

- 2.17 The roof void / loft is accessible from a loft ladder in a hallway cupboard. The roof structure is a typical loose or joiner made roof, comprising off-saw timber ceiling ties, rafter legs, hanging posts and square or butt edged sarking. There is no evidence of roof void ventilation either within the roof space or externally to the building. There is evidence of minor or slight woodworm infestation to the timber roof structure. There is a basic provision of approximately 100-150mm thick glasswool quilt insulation at ceiling level within the roof void. Areas of water ingress / condensation damage to woodwork around cast iron rooflights was evident.

General view of loft / roof void area.

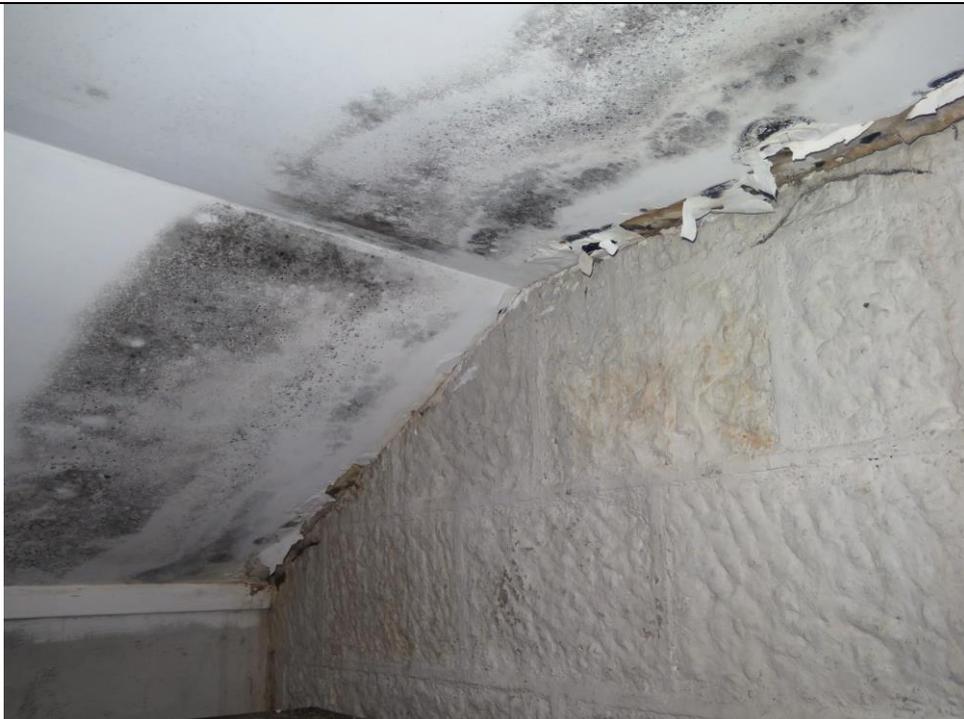
14

- 2.18 Areas of water ingress and dampness were noted to be affecting the ceiling linings or finishes within the boiler house extension to the west end of the subjects below the junction between the boiler house roof and the adjacent gable wall.

Areas of dampness affecting boiler house ceiling linings.

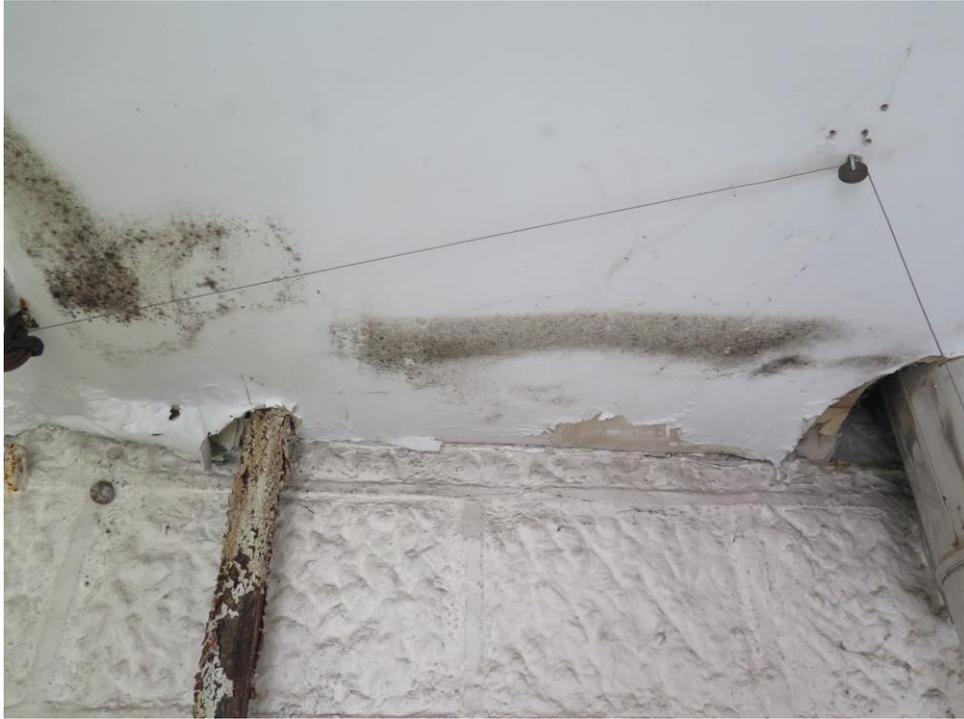
15

Areas of dampness affecting boiler house ceiling linings.

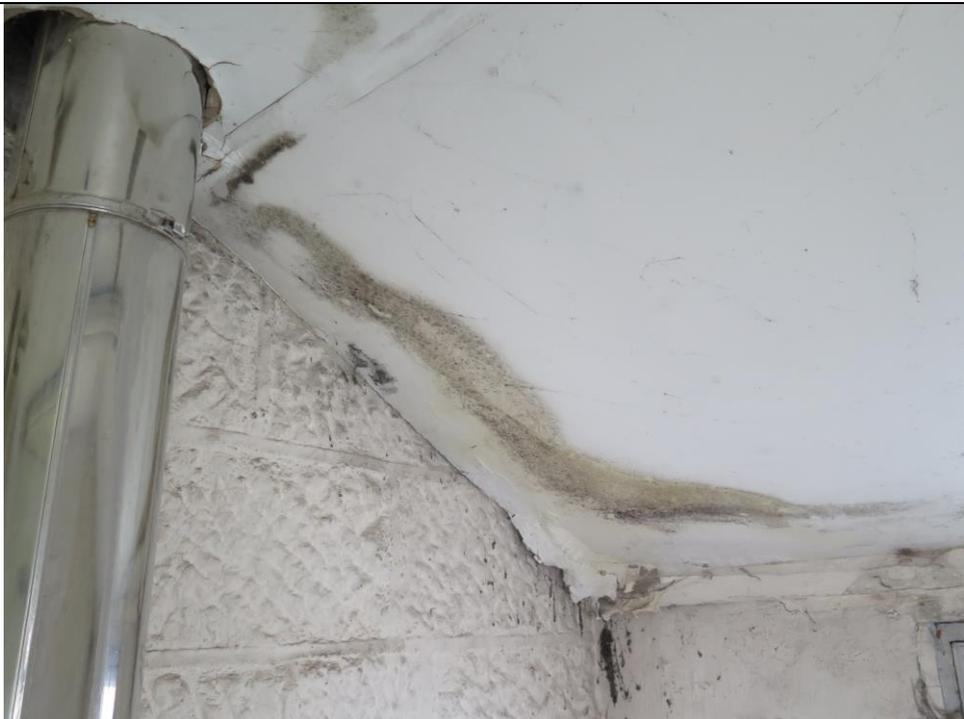
16

Areas of dampness affecting boiler house ceiling linings.

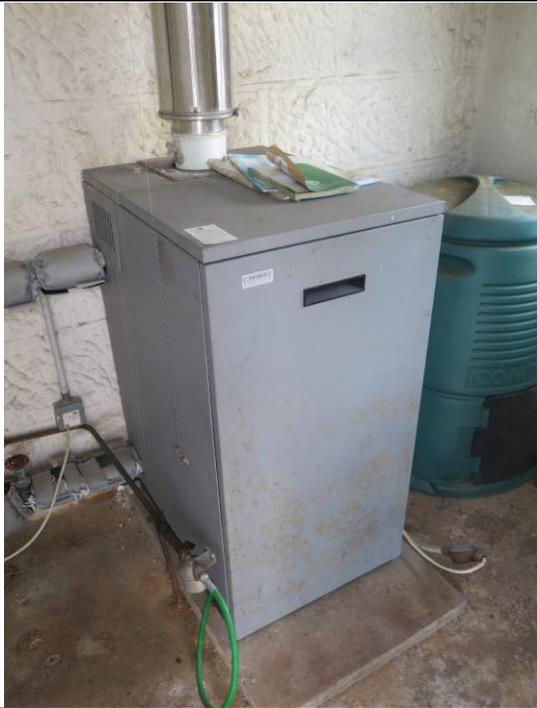
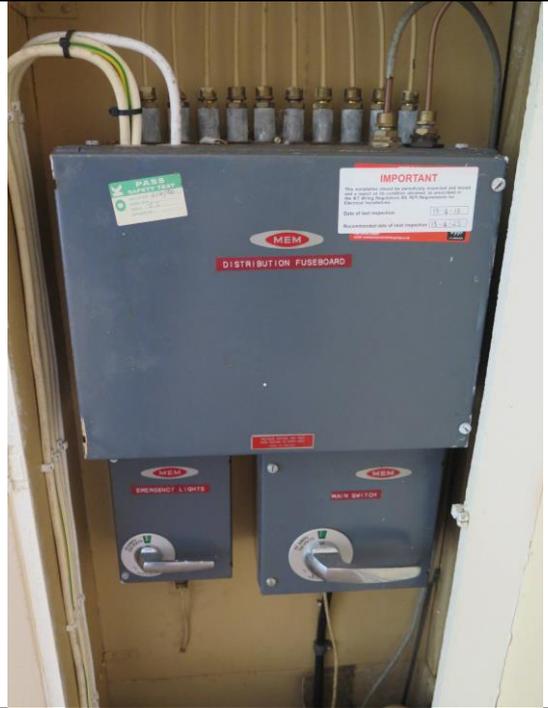
- 2.19 The main heating system is comprised of a floor standing oil fired Camray Utility boiler with standard or unpressurised flow and return mild steel exposed circulation pipework and basic cast iron column style radiators.

- 2.21 Hot water is provided by a wall mounted electrical hot water heater / immersion tank, which is a very old style and very dated.
- 2.22 The main incoming electrical supply is located in a low level cupboard to the east or left hand side of the main entrance, within an adjacent room / office. The meter is located within a proprietary meter box on the external elevation and internally a fairly old cartridge style distribution or fuseboard. The wiring appears to be MICC / pyro style electrical wiring.

General view of Camray Utility floor standing boiler and MEM Memshield DB.
