TREE SURVEY  
&  
ARBORICULTURAL REPORT

Trees at Carron Terrace  
Stonehaven

Requested by: JBA consulting on behalf of Angus Council  
Prepared by: Martin Langton  
Report reference: MGL  
Date: October 2013

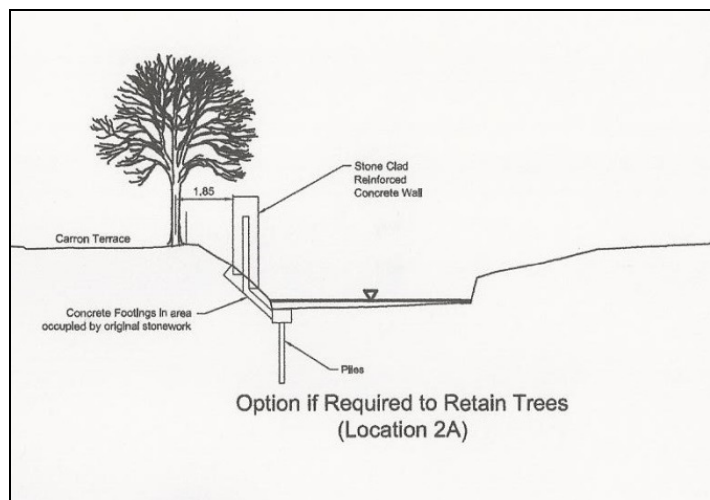
Figure 1: installation of retaining wall beside the Carron Water using mini-piles

- 5.3 Figure 1, above shows the potential use of mini-piles to be used in conjunction with concrete footings replacing the original stonework of buried revetment.

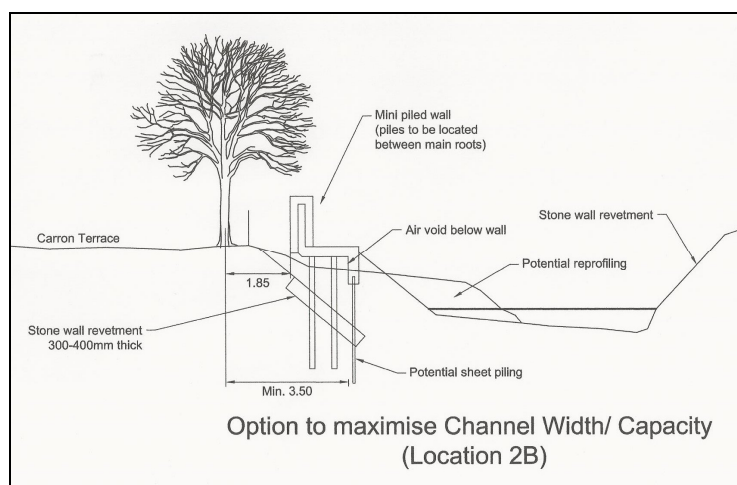
Figure 2: installation of retaining wall by Lime trees using mini-piles. Note: potential use of sheet piling

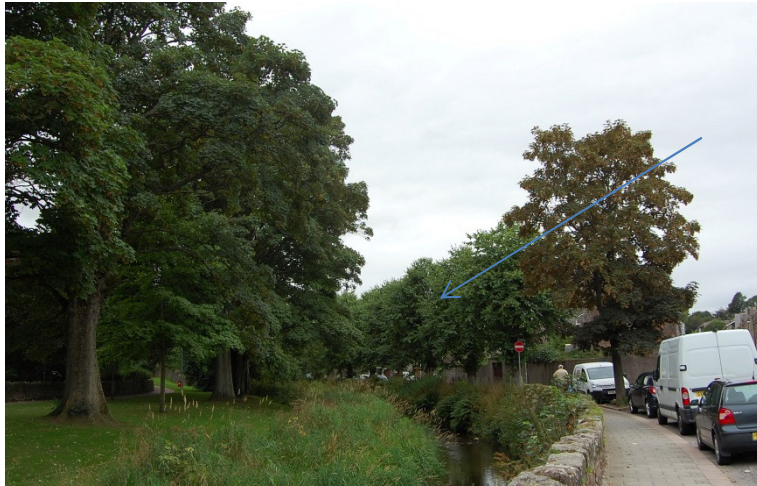
Plate 1a: view west showing pollarded Lime trees by Carron Terrace. Note: effective screening

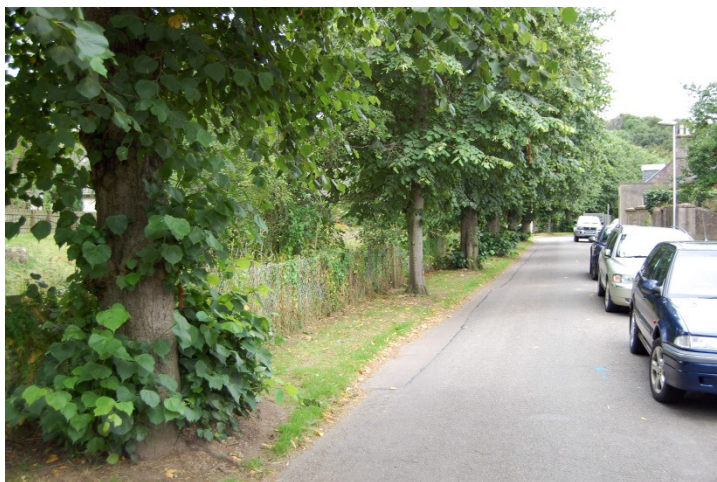
Plate 1b: Pollarded Lime trees providing effective screening along Carron Terrace

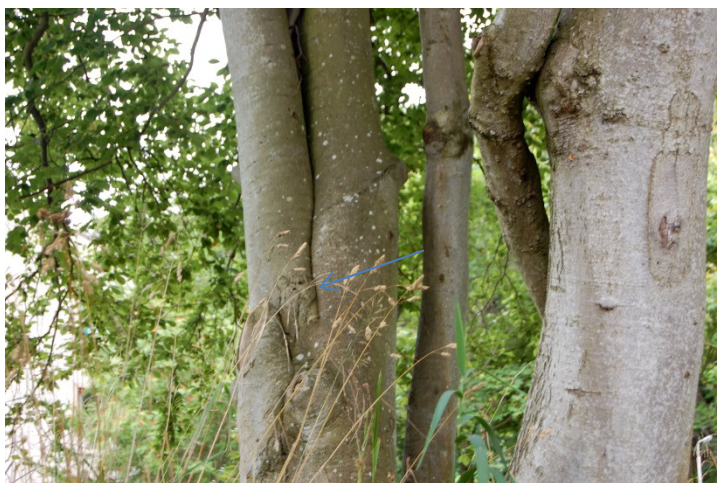
- 4.12 Being closely spaced, the trees tend to be slender and drawn, with strongly asymmetric or suppressed crowns. There is a tendency for structural problems with a high incidence of weak compression unions with included bark and basal decay (see plate 2). I have noted the raised soil levels around the tree bases: the increase in levels can cause problems with root compaction and consequent root die-back, which can lead to deterioration in tree condition and stability problems.

Plate 2: Trees on raised embankment with high incidence of structural defects. Note: weak compression union with included bark

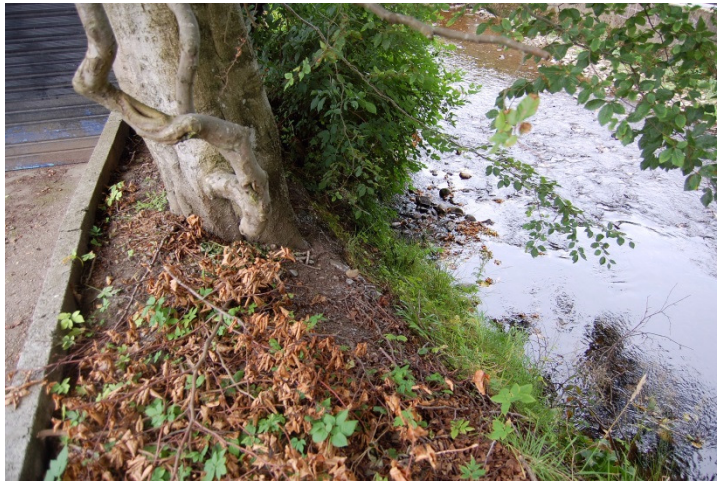
Plate 3: Beech on embankment by Carron Terrace. Note: restricted rooting affected by retaining wall and steep banking

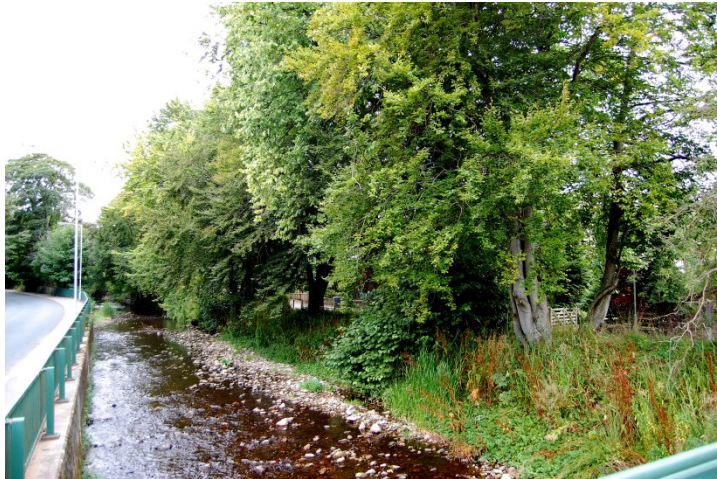
Plate 4: View west from Green Bridge. Note: screening from trees located on raised embankment

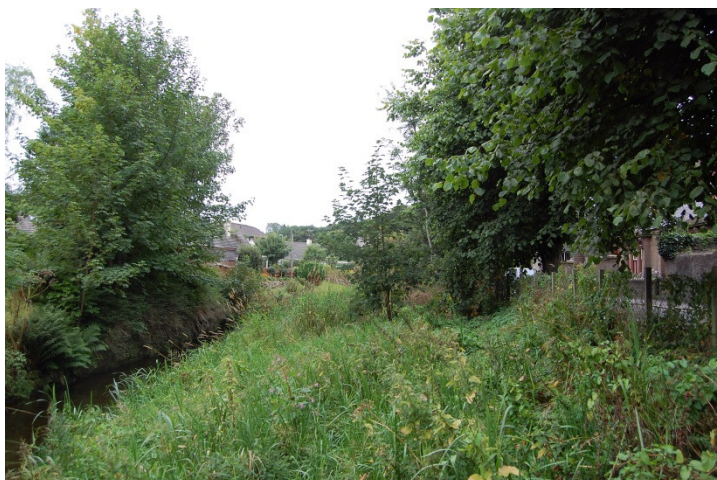
- 4.16 By Carron Terrace: the roots of the Lime trees are likely to be restricted by compacted soils below the tarmac street; by high moisture content and lush vegetation on gently sloping areas by the burn (see plate 5). Regular pollarding will restrict root growth and is likely to reduce activity in the immediate period following pruning. In my opinion the RPAs should extend to around 3.5m south of these trees.

Plate 5: View west showing lush riparian vegetation near pollarded Lime trees
