Pennan

Conservation Area Appraisal

June 2024

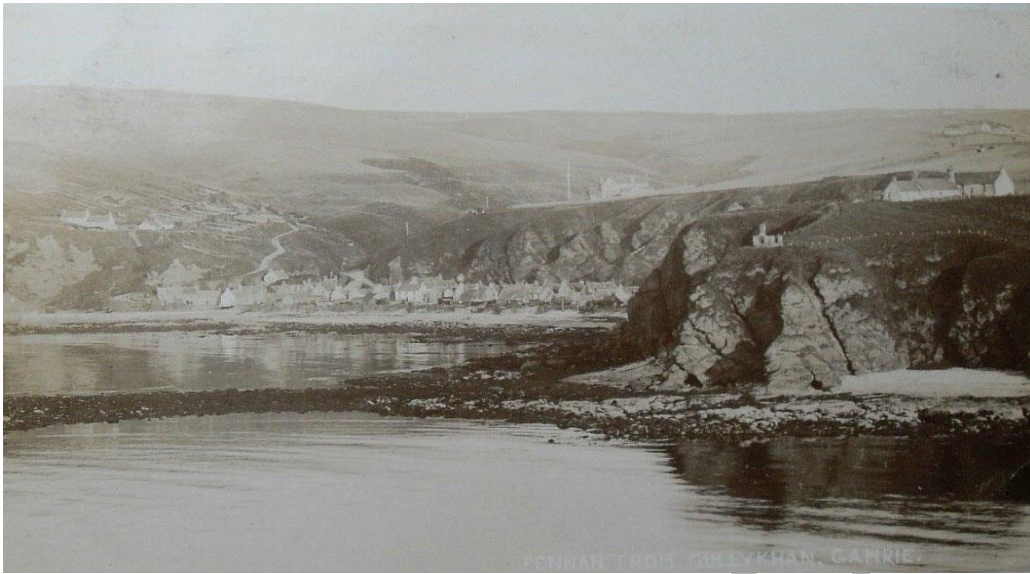
Fig 7 – Early Photograph from the West of Pennan Bay, circa 1903.

Figures 7 and 8 illustrates the two principal routes into and out of Pennan: the eastern road up Black Hill towards the Pennan Farm and New Aberdour, and the south road snaking up the steep slopes above, joining with the main road from Fraserburgh to Banff.

It shows the sloping sandy shore leading up to the sea defences, which were built and maintained by the villagers. These consisted of driven timber posts and heavy-duty timber boards or railway sleepers. Piles of large boulders on the foreshore also served to dissipate the energy of the sea. What is thought to have been the Coast Guard watch house, is on the higher ground of Cullykhan Fort in the foreground. The flagstaff, depicted on the OS Map of 1874, can be seen on top of the hill above Pennan and is likely to have been for Coast Guard use. The large house further up the slope is thought to have been built at the time the image is taken as it is not indicated on OS Maps of 1874 or 1901. It is now 2 houses, Clifftop and Hillcrest. The terraced cottages at the bend, set out in 1837, are hidden behind the slope.

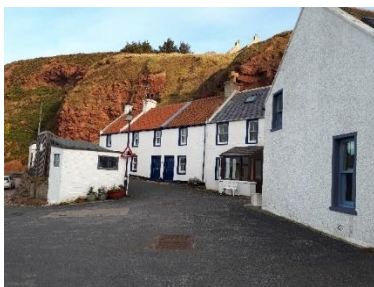
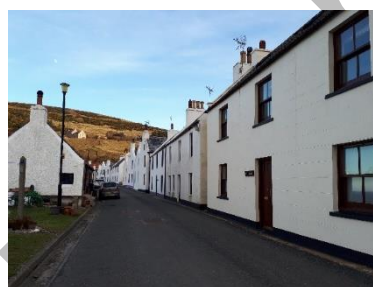
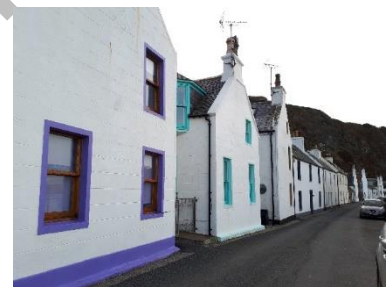
There are two distinct styles of buildings found along the shoreline, those which face the shoreline, and those which have their gable positioned to the shore. These share similarities such as their strong cohesive traditional scales and simple plan forms. They are predominately gabled with chimney stacks, white rendered sandstone walls, with single window and door openings.

Dwellings which are positioned with their gables to the sea, are characteristic of settlements in close proximity to the sea in Aberdeenshire. Traditionally, there would have been no windows positioned on these gables to save them from being damaged in storms, but these have been added in recent years to allow for a pleasant view. These properties have been heightened with the upper floors being converted into living space with the addition of dormer windows.

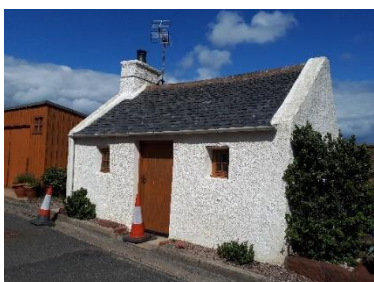
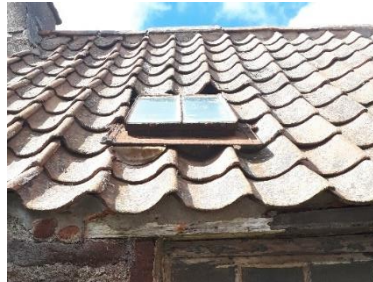
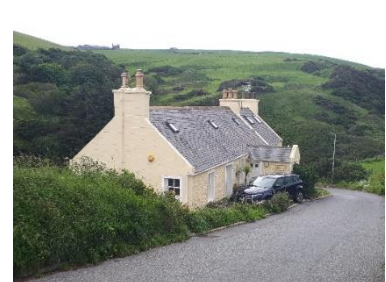
Clay pantiles would have been the traditional roofing material found in Pennan, and some originals can still be seen on some smaller ancillary buildings. Replacements have been carried out using concrete pantiles on properties, where reclaimed clay pantiles would have been preferred. Welsh slate has been used on the majority of properties within the settlement as an alternative roofing material, which is acceptable as a traditional roofing material found in Aberdeenshire, however, clay

pantile is still preferred in this setting. Clay chimney pots can be seen on many properties.

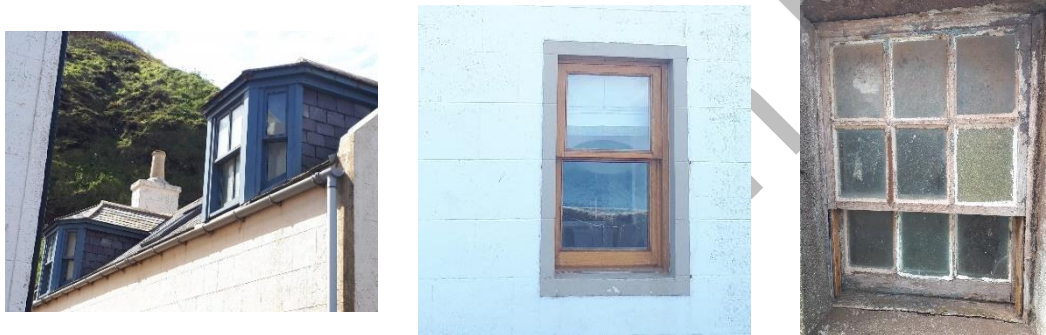
Within Pennan, timber sash and case windows vary considerably in size and design, as well as the design and construction of dormers. There is no one standard design which has been followed throughout the settlement. uPVC windows are seen in some properties in the settlement, as well as oversized box dormers, both of which are not in keeping with the settlement.

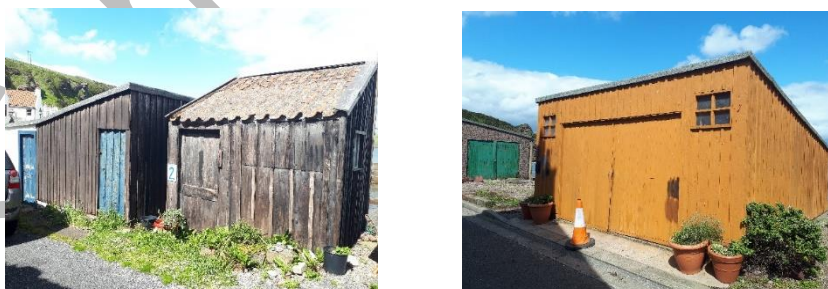
Few sheds/non-domestic buildings are in existence in Pennan, as a large number were lost from the shore during the storm in 1953. There are however a small number of original buildings which remain. Some of these are original, and have been little altered, which provide evidence of the material choices and design which are appropriate in this setting. The materials and shape have been used in new designs within the settlement.

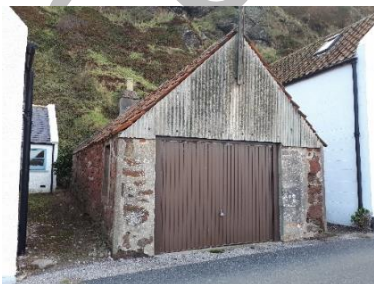
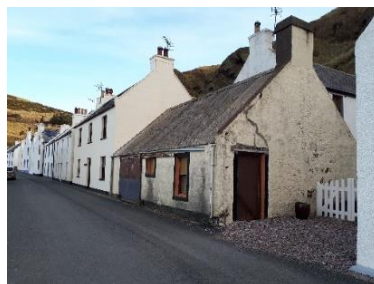
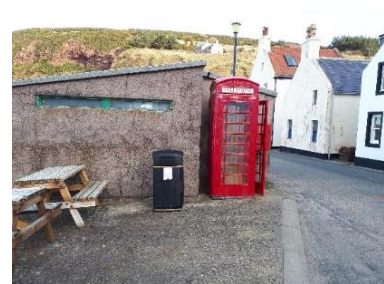
There are a number of ancillary buildings i.e. sheds/garages which have seen less attention given to their maintenance in recent years. On these buildings, missing or damaged rainwater goods are noted and a lack of upkeep in the general appearance of these buildings. Inappropriate materials have also been used on these buildings, such as asbestos, cement harl and uPVC rainwater goods.

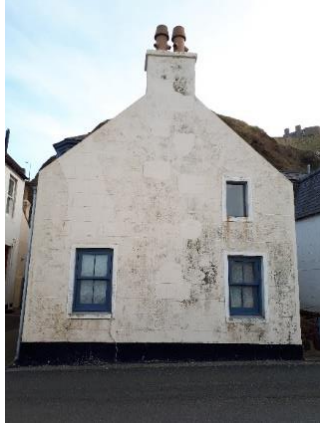
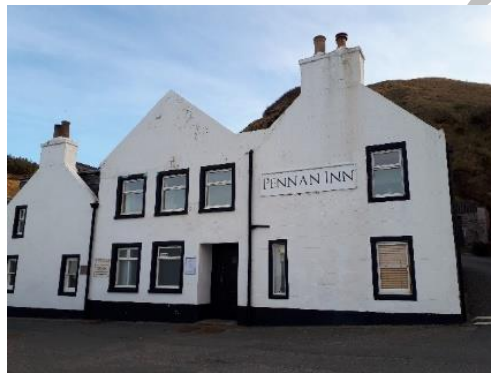
in a different location. Some properties are showing areas of staining which appears to be caused by rusting on elements on the building. This may be from old fixtures to the buildings from when the cabling was above ground.

Some properties have not been as recently painted as others along the shoreline, and therefore are looking tired in comparison. Due to the cement coating on these buildings, when there is a failure to these, it can be noticeable, and if not fixed can cause the coating to further fail. At times of frost, water can get in behind and expand, causing the cement to come away, exposing the stonework below which is likely to be damp underneath.

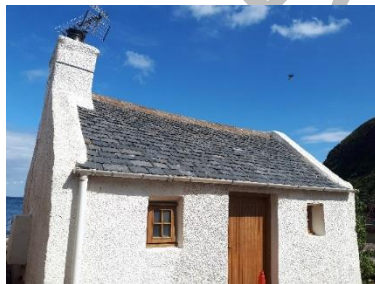
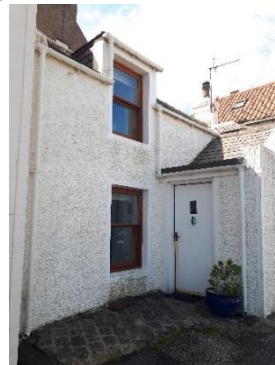
Throughout Pennan, there is a large number of uPVC rainwater goods noted on both residential and non-residential buildings. This is not suitable for conservation areas (or indeed listed buildings) and are better replaced with cast iron alternatives in keeping with the character of the historic settlement.

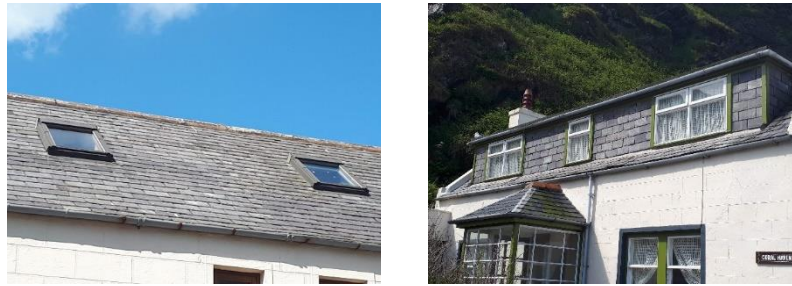
Pennan benefits from the vast majority of properties having timber windows, albeit in a variety of designs and colours. There are a small handful of uPVC windows in Pennan which are not in keeping with the character of the area. The conversion of roof spaces to living accommodation has led to the introduction of a variety of dormers and rooflights to properties. Oversized box dormers and large roof lights are inappropriate within a conservation area therefore, smaller and well-proportioned dormers and conservation rooflights would be more appropriate.
